PHASE I INSPECTION REPORT

NATIONAL DAM SAFETY PROGRAM

4. TITLE and Subtitle Phase I Inspection Report National Dam Safety Program Fawn Lake Dam Spotsylvania County, VA		5. TYPE OF REPORT & PERIOD COVERED Final

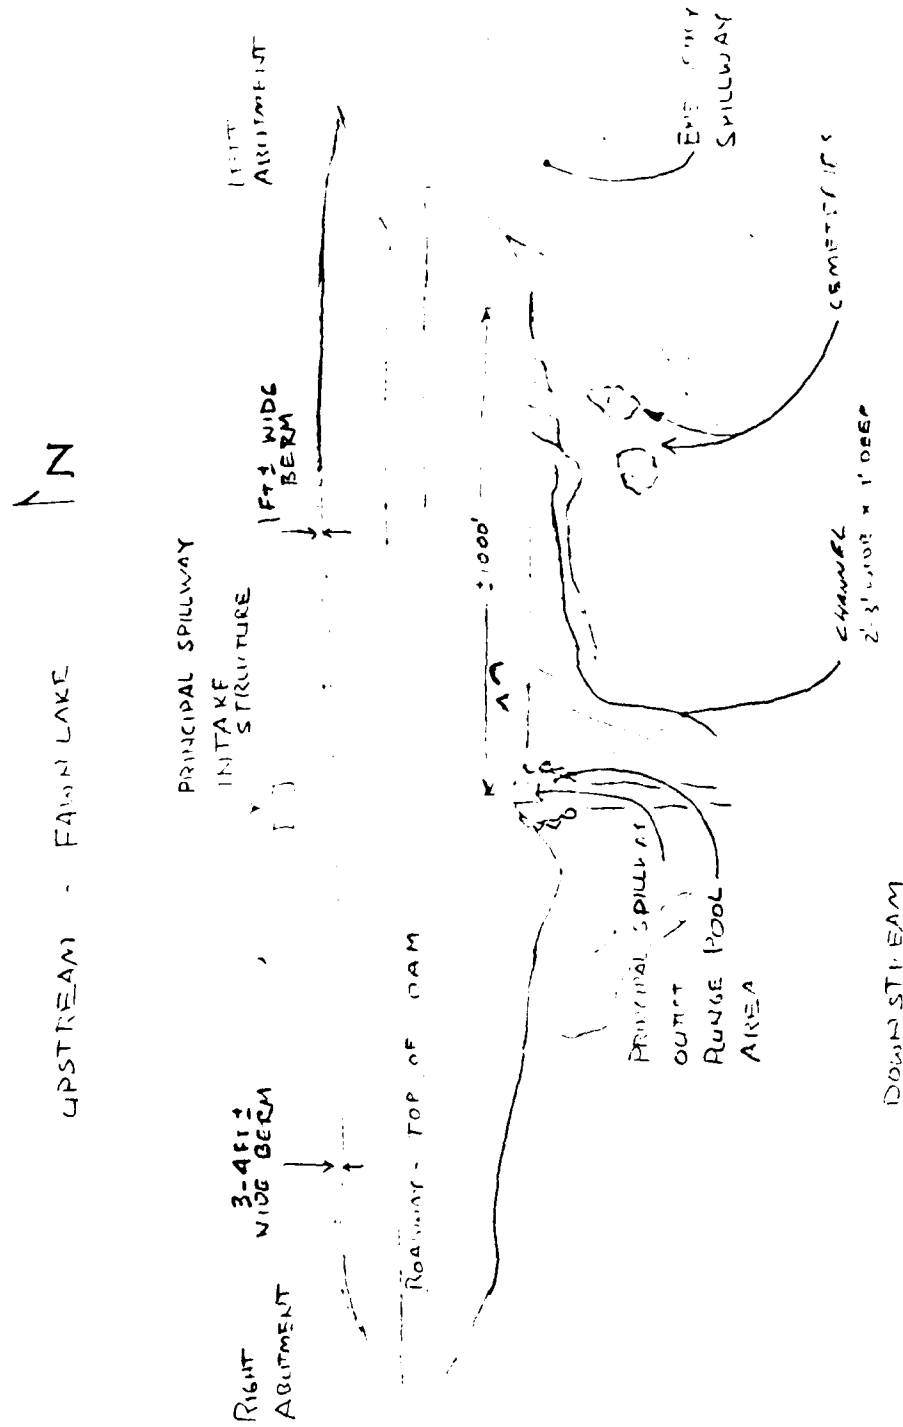
FAWN LAKE DAM FIELD SKETCH NO. 1

A continuous wet area approximately 1000 ft in length occurs along the left downstream toe (see Field Sketch, Sheet 1, Appendix III). Scattered clusters of cattails and marsh grass are present in this area. No flow was observed except where natural sloping ground conditions exist. The water was generally clear and little or no iron staining was observed. This area was of initial concern during the 1979 inspection. During that inspection several hand auger holes were drilled along the left toe of the dam near the cemeteries, beside wet areas. These holes did not fill with water and it was, therefore, concluded that water was not passing through or under the embankment at those locations. At other nearby locations water was standing at elevations estimated several feet above and beyond the toe of the dam. Wet conditions are probably related to springs which were reportedly in existence prior to construction.

Seepage was also observed along the right downstream toe in the same area it was encountered in the 1979 inspection (see Field Sketch, Sheet 1, Appendix III). This area reportedly bounds the former stream channel. Essentially no erosion was encountered on the embankment. The presence of dead trees make this area suspect as to whether this seepage is related to previously existing springs or in fact related

LIMITS OF HAZARDOUS AREAS - SOFT SATURATED GROUND, MAY INCREASE SEE SKETCH NO. 2

SLoughing OR BEHOOO AREAS ± 20' WIDE NO SCALE

7.3.4 Seepage observed along the right downstream toe should be monitored quarterly for increased flows and turbidity. If these conditions should occur, a Professional Engineer with an expertise in Geotechnical Engineering should be contacted to evaluate the problem and make recommendations for required corrective measures. The importance of this precaution cannot be overemphasized since seepage occurring along the former stream channel poses a potential for piping, and thus embankment failure. Seepage observed along the left downstream toe appears to be related to spring seepage, however, a periodic examination of this area is suggested to insure that migration of saturation and erosion of the downstream toe does not occur here.
